**Flood Control Project Maintenance  
Levee Inspections**  
**LMA District Cover Sheet**  
**Spring 2020 Levee Inspection Results**

**Levee District No. 0001 (Glenn County)**

**Spring 2020 Levee Inspection Results**

Waterway			Bank	Unit Miles
Unit No. 01 Sacramento River			Right	12.23
	Spring (March - May)	Summer (June - August)	(September - November) Fall	Winter (December - February)
Unit Maintenance Rating (Fall Only)				
Date of Inspection	4/2/2020 - 4/2/2020			
DWR Inspector	Makar Sokol			
Accompanied By

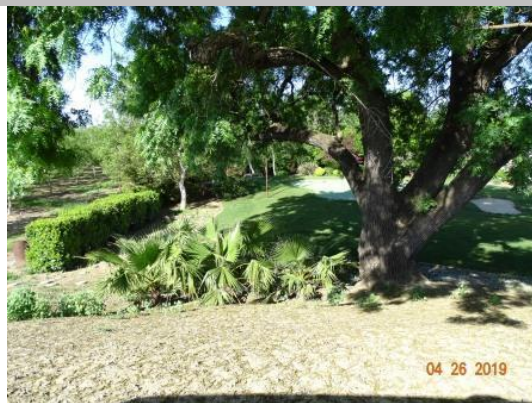
Photo 1 of 1 : SP\_2020\_LD0001G\_432\_53\_20200226\_00012.jpg

View of the palm trees at the landside toe. Spring 2019.

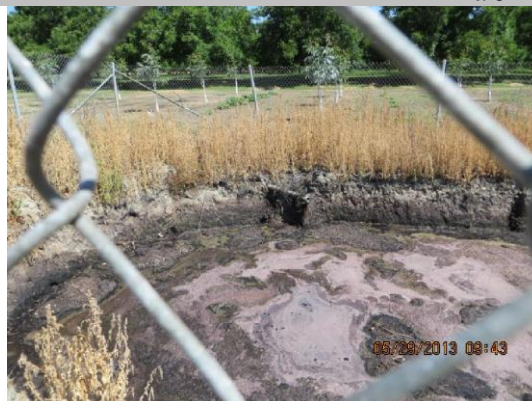
Photo 1 of 3 : UCIP\_SP\_2020\_14324\_23564.jpg

LM Start	0.77	Rating **	M	Issue No.	96	
LM End	0.77	Issue Type +	En	Location *		
Category	Supplemental			GPS Latitude/Longitude		
				Start		End
Item	DWR UCIP Field Study			39.487806 °		39.487806 °
				-122.019414 °		-122.019414 °
DWR ID	22893					
Comment Code						
Inspector Comment						
DS_ID:22893 FS_ID:14324 EP_NO: 11782 Repair Type: Non-Urgent Crossing Status: Found UCIP Comments: 5/29/2013 - Siphon breaker missing from WS shoulder (W. Wylie - DWR UCIP) FIELD_STRUCT_DESC: 3-inch galvanized steel water pipe through the levee, 2 feet below the crown. There is a hose bib style siphon breaker on the waterside (WS) shoulder. A pipe runs from the concrete sump next to the barn on the landside (LS) to a cesspool off of the WS toe. (Permit No. 11782, 1976 - Carriere Brothers). [Additional Reference(s): DWR Levee Log, 1992]. FS Date: 5/29/2013

3-inch pipe at cesspool off WS toe.

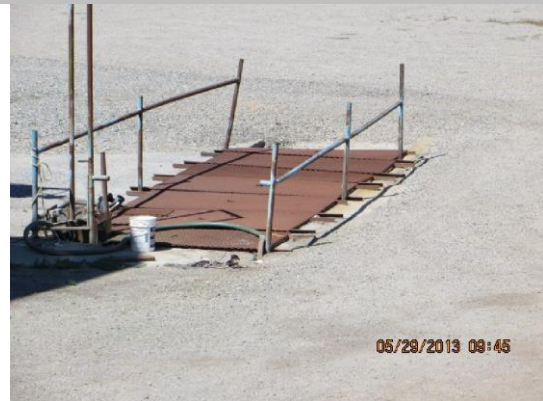
Photo 3 of 3 : UCIP\_SP\_2020\_14324\_23562.jpg

Concrete sump next to barn off LS toe.

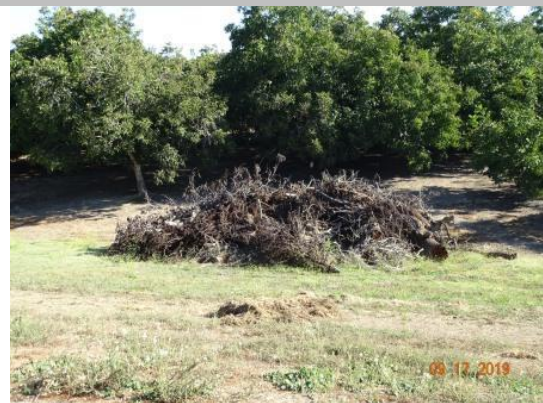
Photo 1 of 1 : SP\_2020\_LD0001G\_432\_41\_20200226\_00008.jpg

LM Start	0.77	Rating **	M	Issue No.	41
LM End	0.77	Issue Type +	En	Location *	WS
Category	Earthen Levee			GPS Latitude/Longitude	
				Start	End
Item	Encroachments			39.487890 °	39.487890 °
				-122.019529 °	-122.019529 °
DWR ID	DWR_LD0001G_01_f_2019_41				
Comment Code					
PR : Prunings					
Inspector Comment					
The pile of prunings should be removed from the waterside toe.

View of the prunings along the waterside toe. Fall 2019.

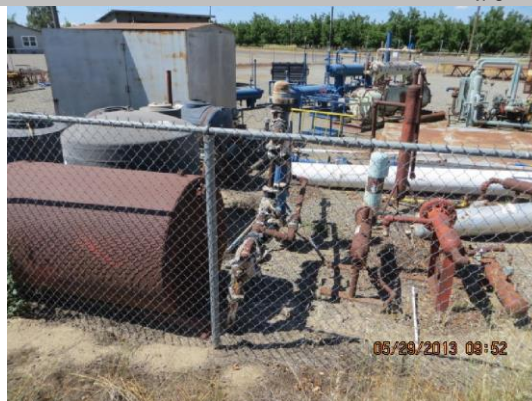
Photo 1 of 3 : UCIP\_SP\_2020\_14325\_23568.jpg

LM Start	0.80	Rating **	M	Issue No.	97
LM End	0.80	Issue Type +	En	Location *	
Category	Supplemental			GPS Latitude/Longitude	
				Start	End
Item	DWR UCIP Field Study			39.488160 °	39.488160 °
				-122.019888 °	-122.019888 °
DWR ID	22894				
Comment Code					
Inspector Comment					
DS_ID:22894 FS_ID:14325 EP_NO: 1837 Repair Type: Non-Urgent Crossing Status: Indicator Found UCIP Comments: 5/29/2013 - Gasline appears abandoned, need to verify abandonment or mark actual pipe location. (W. Wylie - DWR UCIP) FIELD_STRUCT_DESC: 3-inch gas pipeline of an unknown material through the levee, 2 feet below the crown. Fenced in pumping plant area next to levee with appurtenances. (Permit No. 1837, 1953 - Sunray Oil Corporation). [Additional Reference(s): DWR Levee Log, 1992]. FS Date: 5/29/2013

Gas pumping plant and appurtenances.

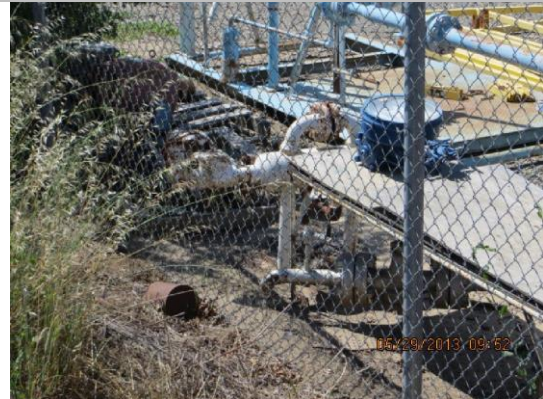
Photo 2 of 3 : UCIP\_SP\_2020\_14325\_23567.jpg

Possible pipe at crossing, LS toe.

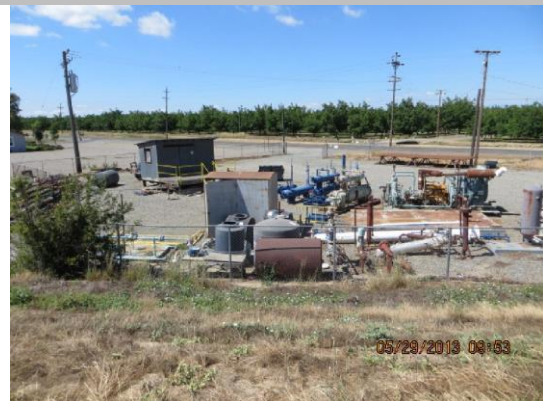
Photo 3 of 3 : UCIP\_SP\_2020\_14325\_23566.jpg

Gas pumping plant and appurtenances.

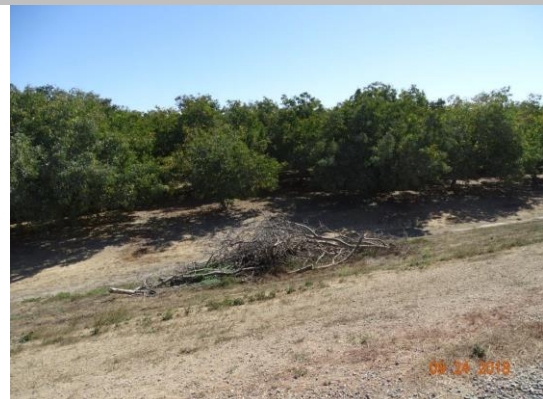
Photo 1 of 1 : SP\_2020\_LD0001G\_432\_61\_20200226\_00016.jpg

LM Start	0.92	Rating **	M	Issue No.	61
LM End	0.92	Issue Type +	En	Location *	WS
Category	Earthen Levee			GPS Latitude/Longitude	
				Start	End
Item	Encroachments			39.489718 °	39.489718 °
				-122.020650 °	-122.020650 °
DWR ID	DWR_LD0001G_01_f_2018_61				
Comment Code					
PR : Prunings					
Inspector Comment					
Prunings should be removed from the waterside toe.

View of the prunings along the waterside toe.

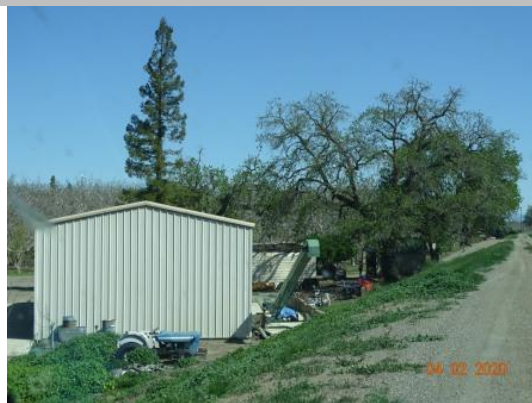
Photo 1 of 1 : SP\_2020\_LD0001G\_432\_4\_20200413\_00097.jpg

View of the unpermitted building at the landside toe. Spring 2020.

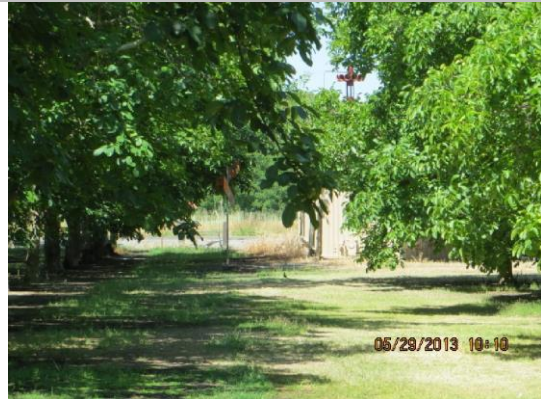
Photo 1 of 1 : UCIP\_SP\_2020\_14327\_23569.jpg

LM Start	1.25	Rating **	M	Issue No.	99
LM End	1.25	Issue Type +	En	Location *	
Category	Supplemental			GPS Latitude/Longitude	
				Start	End
Item	DWR UCIP Field Study			39.493977 °	39.493977 °
				-122.018380 °	-122.018380 °
DWR ID	22896				
Comment Code					
Inspector Comment					
DS_ID:22896 FS_ID:14327 EP_NO: 2171 Repair Type: Non-Urgent Crossing Status: Indicator Found UCIP Comments: Appears abandoned as well off LS toe has been removed. Need to remove from levee or mark as appropriate. FIELD_STRUCT_DESC: 2 of 2: 3-inch gas pipeline of an unknown material through the levee, 2 feet below the crown. Abandoned gas pumping station 260 feet off the landside (LS) toe. (Permit No. 2171, 1955 - Sunray Mid-Continent Oil Company). [Additional Reference(s): DWR Levee Log, 1992]. FS Date: 5/29/2013

Gasline markers near where removed pumping plant was located.

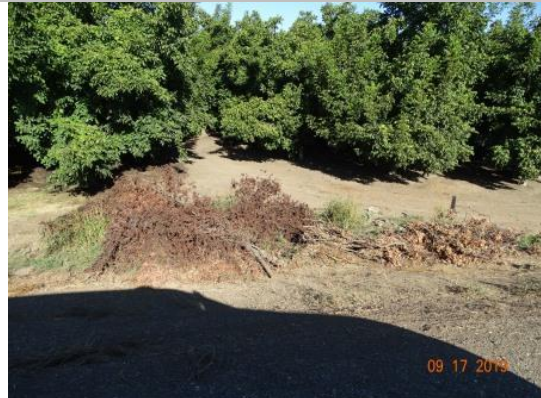
Photo 1 of 1 : SP\_2020\_LD0001G\_432\_64\_20200226\_00017.jpg

LM Start	1.25	Rating **	M	Issue No.	64
LM End	1.25	Issue Type +	En	Location *	LS
Category	Earthen Levee			GPS Latitude/Longitude	
				Start	End
Item	Encroachments			39.494080 °	39.494080 °
				-122.018329 °	-122.018329 °
DWR ID	DWR_LD0001G_01_f_2019_64				
Comment Code					
PR : Prunings					
Inspector Comment					
The pile of prunings should be removed from the landside slope and toe.

View of the pile of prunings along the landside slope and toe. Fall 2019.

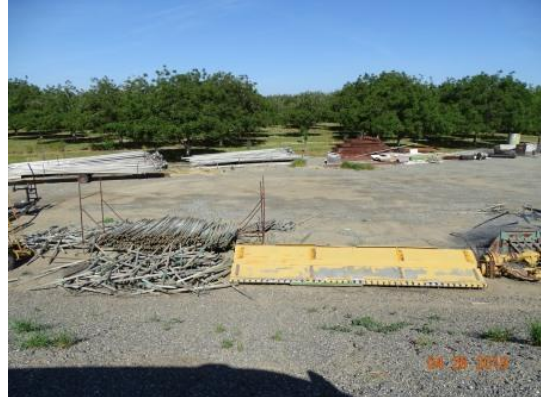
Photo 1 of 1 : SP\_2020\_LD0001G\_432\_71\_20200226\_00021.jpg

View of the farm equipment and materials at the landside toe. Spring 2019.

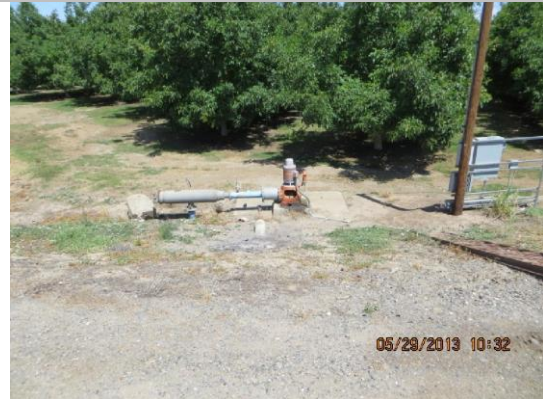
Photo 1 of 2 : UCIP\_SP\_2020\_14331\_23579.jpg

LM Start	2.22	Rating **	M	Issue No.	101	
LM End	2.22	Issue Type +	En	Location *		
Category	Supplemental			GPS Latitude/Longitude		
				Start	End	
Item	DWR UCIP Field Study			39.501690 °	39.501690 °	
				-122.006100 °	-122.006100 °	
DWR ID	22898					
Comment Code						
Inspector Comment						
DS_ID:22898 FS_ID:14331 EP_NO: 5717A Repair Type: Non-Urgent Crossing Status: Found UCIP Comments: Pipe abandoned and should be done so properly. FIELD_STRUCT_DESC: 8-inch asbestos cement irrigation pipe sleeved through a 12-inch pipe through the levee, 5 feet below the crown. Pump located on the landside (LS). Meter pole located on the LS toe. Guy wire anchor in LS slope. (Permit No. 5717-A, 1969 - W. A. Carriere). [Additional Reference(s): DWR Levee Log, 1992]. FS Date: 5/29/2013

Pump at LS toe with no connection to 8-inch pipe.

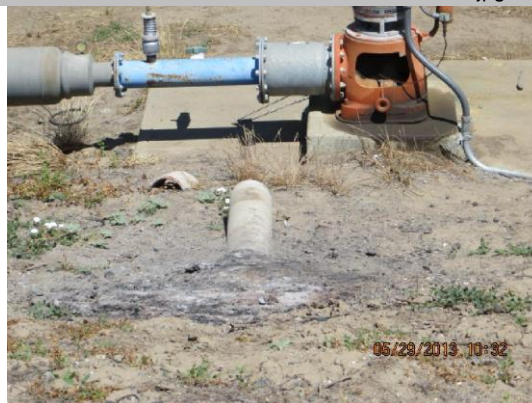
Photo 2 of 3 : UCIP\_SP\_2020\_14332\_23581.jpg

Pipe next to pump at LS toe.

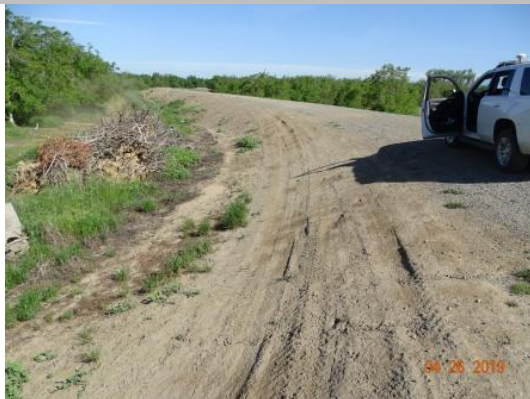
Photo 1 of 1 : SP\_2020\_LD0001G\_432\_77\_20200226\_00024.jpg

LM Start	3.04	Rating **	M	Issue No.	77
LM End	3.04	Issue Type +	Ma	Location *	LS
Category	Earthen Levee			GPS Latitude/Longitude	
				Start	End
Item	Slope Stability			39.512932 °	39.512932 °
				-122.009074 °	-122.009074 °
DWR ID	DWR_LD0001G_01_s_2019_77				
Comment Code					
S3 : Repair the levee slope damaged by vehicle traffic and prevent access where possible.					
Inspector Comment

View of the landside slope damaged by vehicle traffic. Spring 2019.

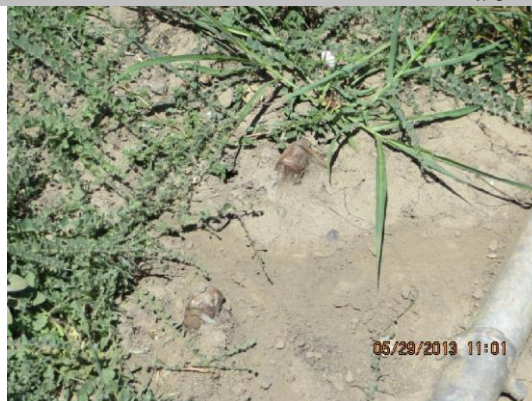
Photo 1 of 2 : UCIP\_SP\_2020\_54250\_27343.jpg

LM Start	3.13	Rating **	M	Issue No.	103
LM End	3.13	Issue Type +	En	Location *	
Category	Supplemental			GPS Latitude/Longitude	
				Start	End
Item	DWR UCIP Field Study			39.513835 °	39.513835 °
				-122.010029 °	-122.010029 °
DWR ID	22901				
Comment Code					
Inspector Comment					
DS_ID:22901 FS_ID:54250 EP_NO: 9575 Repair Type: Non-Urgent Crossing Status: Found UCIP Comments: Appears to have been abandoned. Need to verify pipe was grouted/abandoned properly. FIELD_STRUCT_DESC: *ABANDONED* 12-inch drainage pipe of an unknown material through the levee, 14 feet below the crown. Flap Gate on the waterside (WS) end. (Automatic Board Order (ABO) issued as Permit No. 9575, 1974 - Franklin Emmett, Bette Lou Dillard Jr., and McIntyre). [Additional Reference(s): DWR Levee Log, 1992]. FS Date: 5/29/2013

Flap gate visible at WS toe.

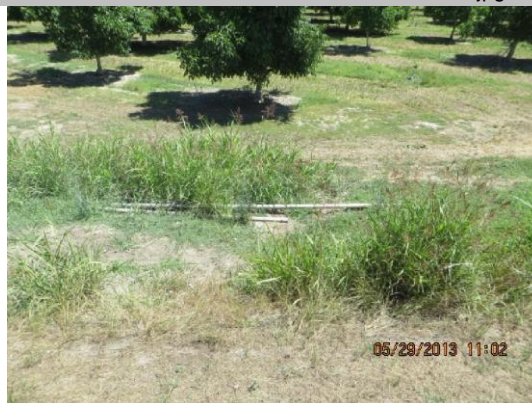
Photo 2 of 2 : UCIP\_SP\_2020\_54250\_27342.jpg

Flap gate visible at WS toe.

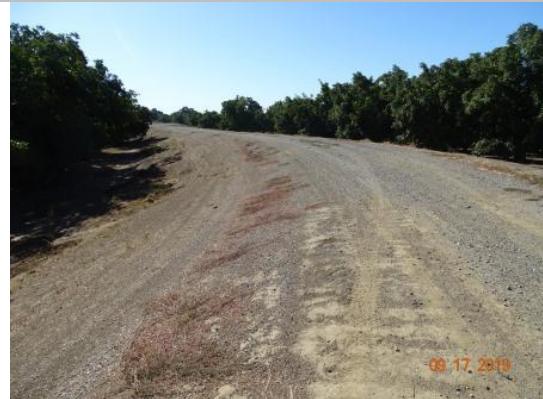
Photo 1 of 1 : SP\_2020\_LD0001G\_432\_68\_20200226\_00019.jpg

LM Start	3.26	Rating **	M	Issue No.	68
LM End	3.26	Issue Type +	Ma	Location *	WS
Category	Earthen Levee			GPS Latitude/Longitude	
				Start	End
Item	Slope Stability			39.515595 °	39.515595 °
				-122.011152 °	-122.011152 °
DWR ID	DWR_LD0001G_01_f_2019_68				
Comment Code					
S3 : Repair the levee slope damaged by vehicle traffic and prevent access where possible.					
Inspector Comment

View of the waterside slope damaged by vehicle traffic. Fall 2019.

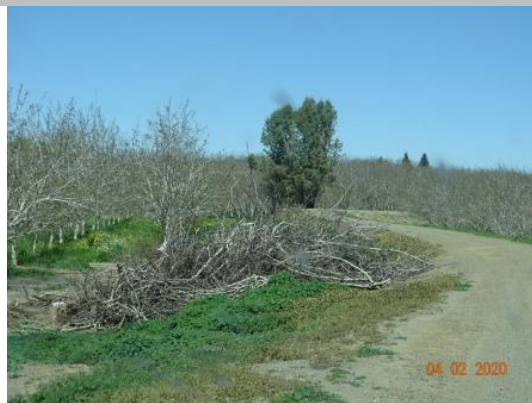
Photo 1 of 1 : SP\_2020\_LD0001G\_432\_56\_20200413\_00098.jpg

View of the prunings and limbs along the landside toe. Spring 2020.

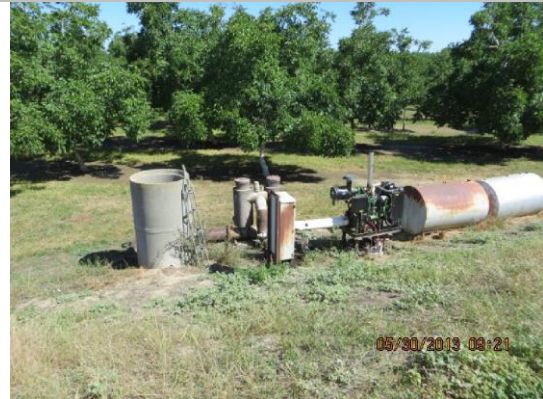
Photo 1 of 3 : UCIP\_SP\_2020\_51284\_23594.jpg

Comment Code					
Inspector Comment					
DS_ID:22906 FS_ID:51284 EP_NO: 1229 Repair Type: Non-Urgent Crossing Status: Found UCIP Comments: 12/21/2016 same as last inspection. Crossing has been modified from original permit. Need to contact owner to determine permit number issued for modification and to determine current status of crossing. Crossing has been downgraded from Urgent to Non-Urgent due to no damage observed on levee slopes or crown. (O. Magana - DWR UCIP)05/30/2013 Gate valve broken off in concrete standpipe on WS shoulder. 8-inch aluminum pipe sleeved through pipe prevents closure of 18-inch pipe. All concrete standpipes have been modified or broken. (W. Wylie - DWR UCIP) FIELD_STRUCT_DESC: 16-inch concrete (not 18-inch asphalt dipped steel as referenced in permit or USACE O&M manual) irrigation pipe through the levee, 8.6 feet below the crown. Gate valve in concrete well located on the waterside (WS) slope. Pump, service pole, engine, and fuel tank 48-inch, and standpipe are located on the toe of the landside (LS) slope (Permit No. 1229, 1947 - R. T. Miller). [Additional Reference(s): DWR Levee Log, 1992. USACE Sacramento O&M Manual Unit 140, May 1960, (HLM 4.33)]. FS Date: 12/21/2016

Pump, standpipe, and gate valve on LS toe.

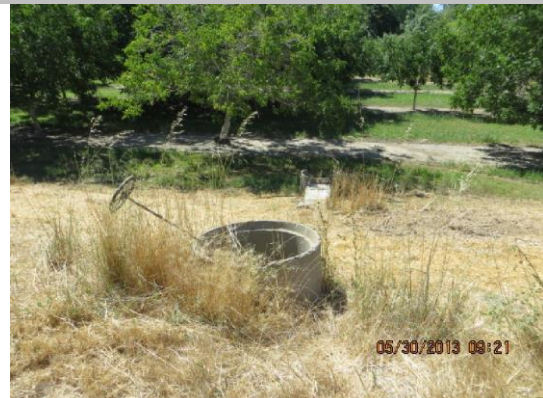
Photo 2 of 3 : UCIP\_SP\_2020\_51284\_23593.jpg

Gate valve in Concrete riser on WS shoulder.

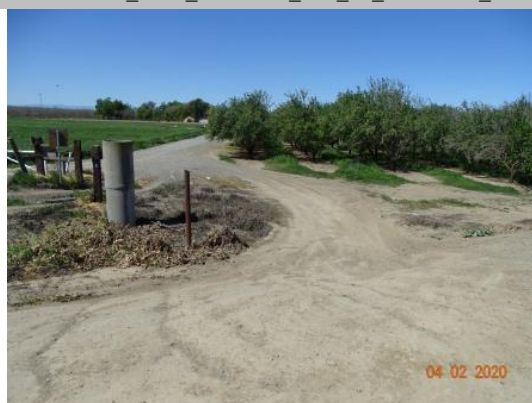
Photo 1 of 1 : SP\_2020\_LD0001G\_432\_57\_20200413\_00099.jpg

LM Start	5.06	Rating **	M	Issue No.	57
LM End	5.06	Issue Type +	Ma	Location *	LS
Category	Earthen Levee			GPS Latitude/Longitude	
				Start	End
Item	Slope Stability			39.534593 °	39.534593 °
				-121.995950 °	-121.995950 °
DWR ID	DWR_LD0001G_01_f_2013_57				
Comment Code					
S3 : Repair the levee slope damaged by vehicle traffic and prevent access where possible.					
Inspector Comment

View of the vehicle erosion along the landside slope Spring 2020.

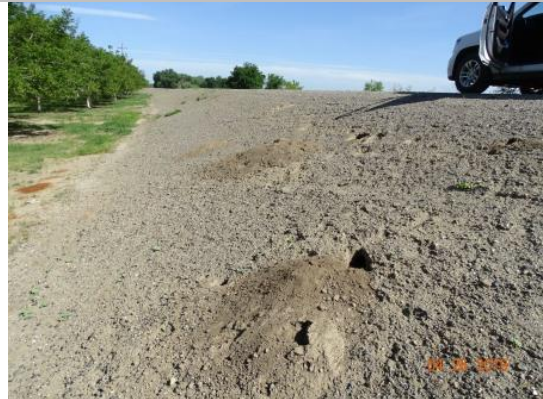
Photo 1 of 1 : SP\_2020\_LD0001G\_432\_82\_20200226\_00026.jpg

View of the rodent activity on the landside slope. Spring 2019.

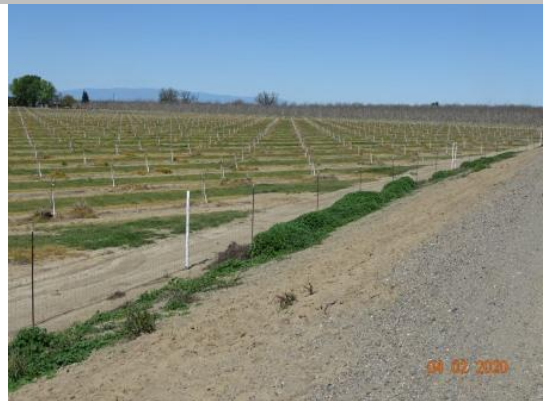
Photo 1 of 1 : SP\_2020\_LD0001G\_432\_62\_20200413\_00100.jpg

LM Start	5.53	Rating **	M	Issue No.	62
LM End	5.59	Issue Type +	Ma	Location *	LS
Category	Earthen Levee			GPS Latitude/Longitude	
				Start	End
Item	Slope Stability			39.540857 °	39.541669 °
				-121.999174 °	-121.999642 °
DWR ID	DWR_LD0001G_01_s_2020_62				
Comment Code					
S3 : Repair the levee slope damaged by vehicle traffic and prevent access where possible.					
Inspector Comment

View of the landside levee slope damaged by vehicle traffic. Spring 2020.

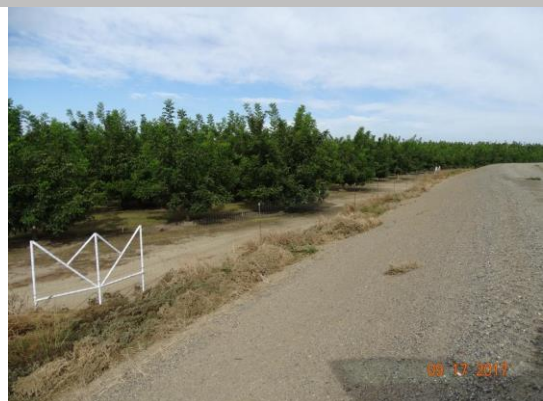
Photo 1 of 1 : SP\_2020\_LD0001G\_432\_78\_20200226\_00025.jpg

View of the fence along the landside toe.

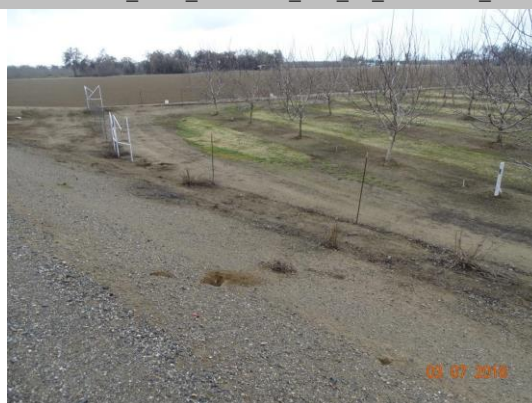
Photo 1 of 1 : SP\_2020\_LD0001G\_432\_70\_20200226\_00020.jpg

View of the rodent holes along the landside slope.

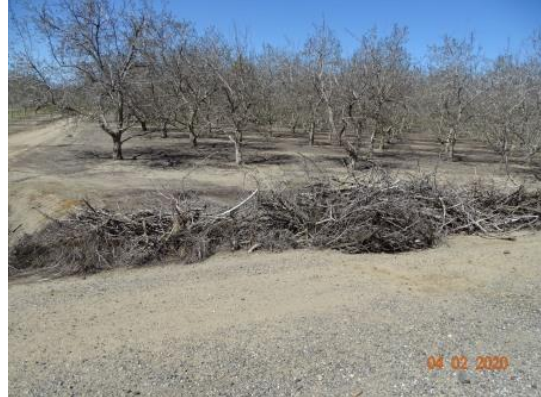
Photo 1 of 1 : SP\_2020\_LD0001G\_432\_54\_20200413\_00101.jpg

View of the prunings along the landside toe. Spring 2020.

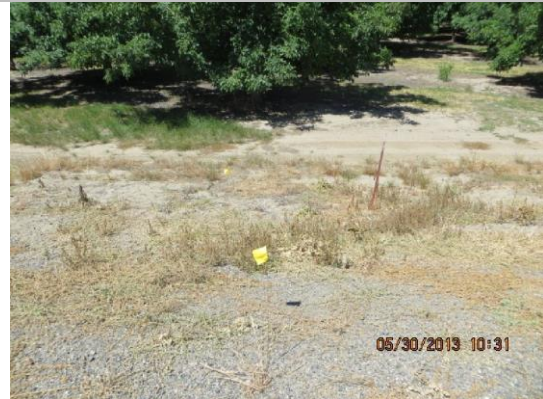
Photo 1 of 2 : UCIP\_SP\_2020\_14352\_23609.jpg

Gasline flags on LS slope.

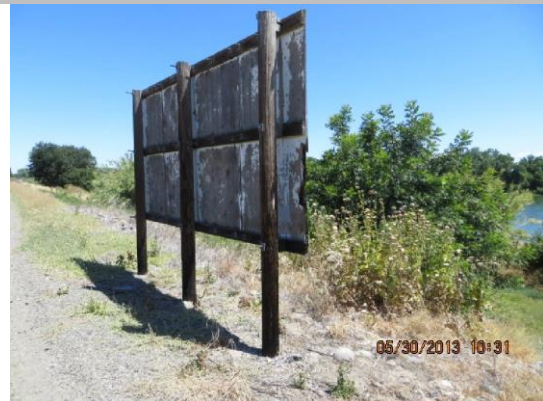
Photo 2 of 2 : UCIP\_SP\_2020\_14352\_23608.jpg

Gasline sign on WS shoulder.

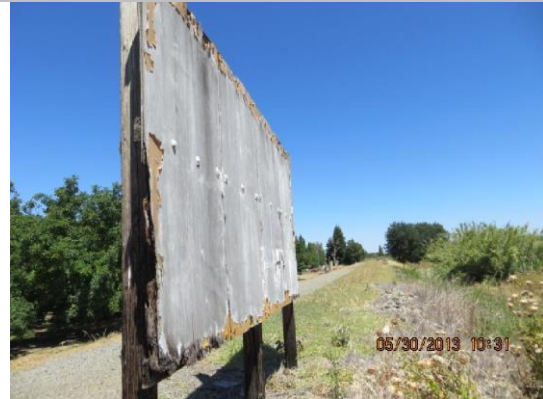
Photo 1 of 1 : UCIP\_SP\_2020\_16224\_27345.jpg

Gasline sign on WS shoulder.

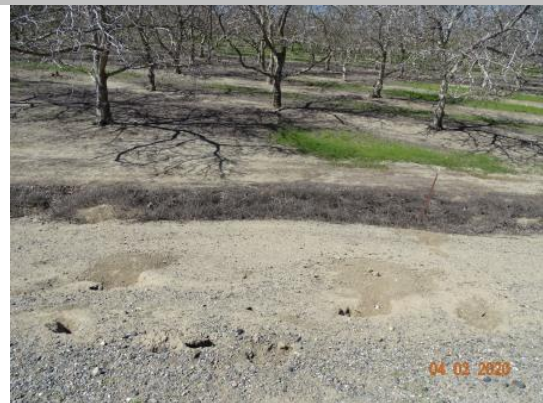
Photo 1 of 1 : SP\_2020\_LD0001G\_432\_47\_20200413\_00102.jpg

View of the rodent holes along the landside slope. Spring 2020.

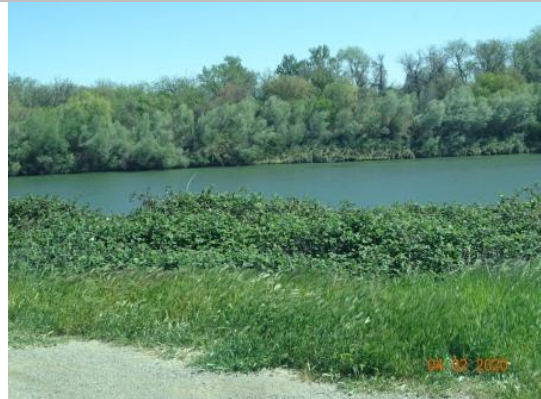
Photo 1 of 1 : SP\_2020\_LD0001G\_432\_10\_20200413\_00103.jpg

View of the Army Corps of Engineers mitigation site. Spring 2020.

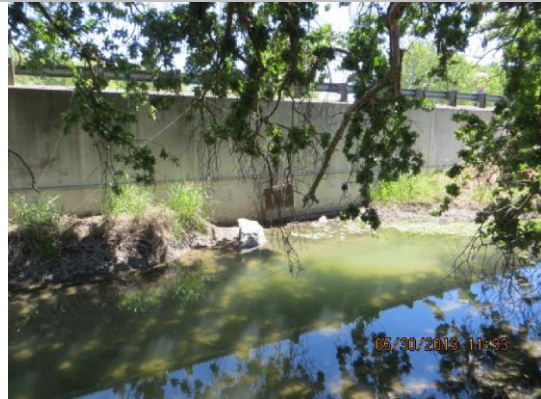
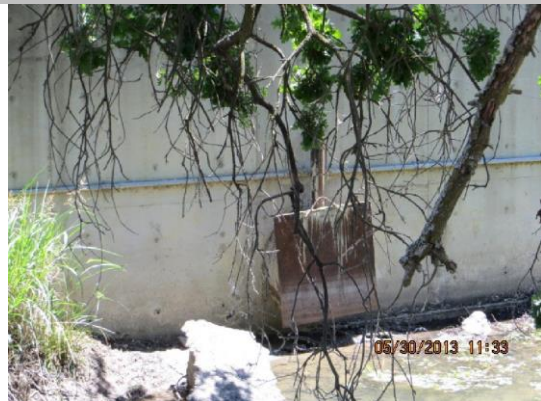
Pipe with steel plate welded over end on LS of levee crown.

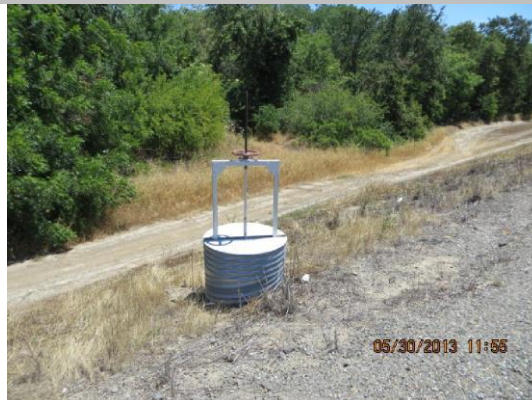
Photo 2 of 3 : UCIP\_SP\_2020\_14384\_23663.jpg

Slide gate in 36-inch CMP standpipe on WS slope

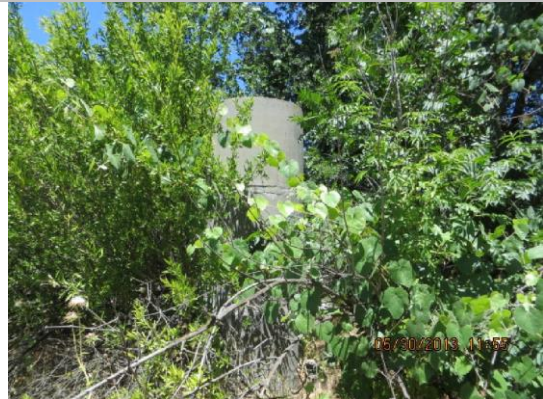
Photo 3 of 3 : UCIP\_SP\_2020\_14384\_23662.jpg

Concrete standpipe off WS toe.

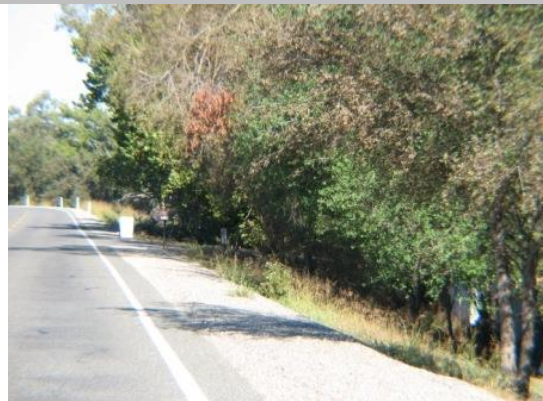
Photo 1 of 1 : SP\_2020\_LD0001G\_432\_20\_20200226\_00006.jpg

View of the trees and vegetation along the waterside slope of the levee.

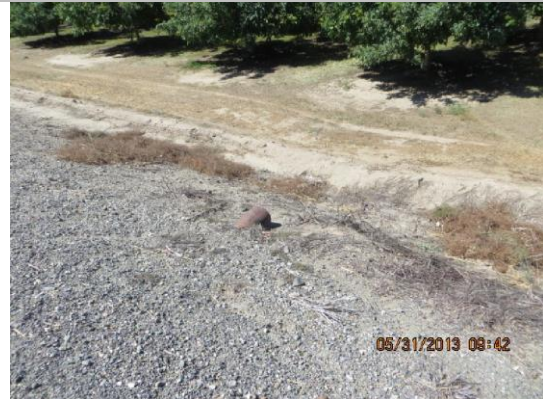
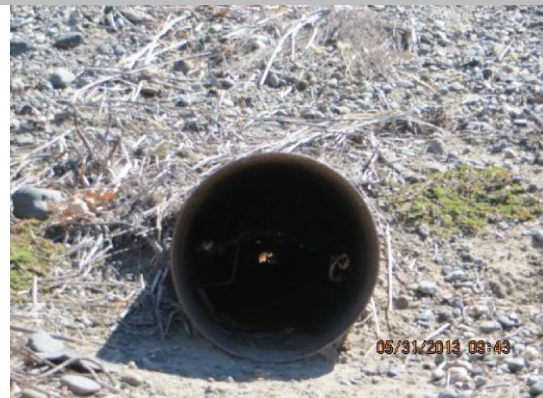
Pipe on LS slope.

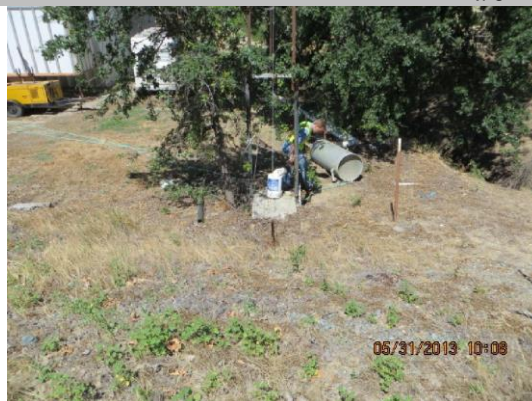
Photo 1 of 3 : UCIP\_SP\_2020\_16204\_27330.jpg

Pipe visible next to well with bucket over standpipe.

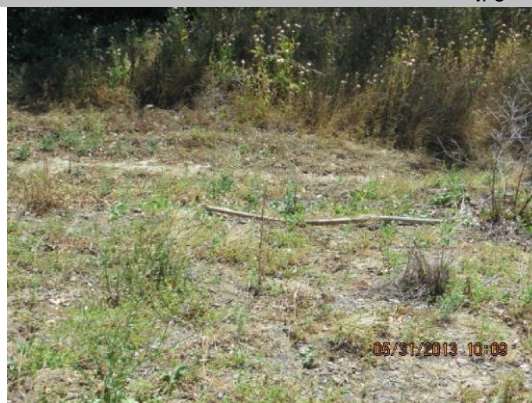
Photo 3 of 3 : UCIP\_SP\_2020\_16204\_27328.jpg

Pipe debris on WS slope may be indicator of pipe location on WS.

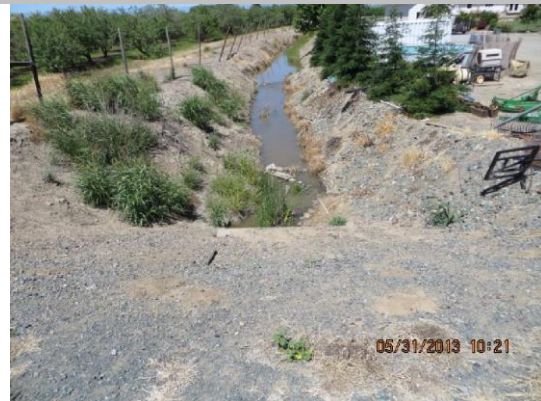
Photo 1 of 3 : UCIP\_SP\_2020\_14389\_23686.jpg

Pipe and headwall at LS toe.

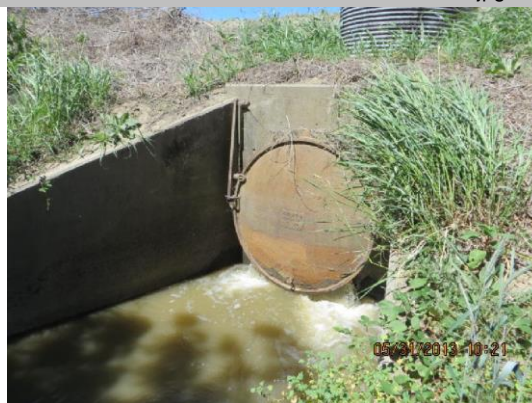
Photo 3 of 3 : UCIP\_SP\_2020\_14389\_23684.jpg

Flap gate and headwall on WS toe.

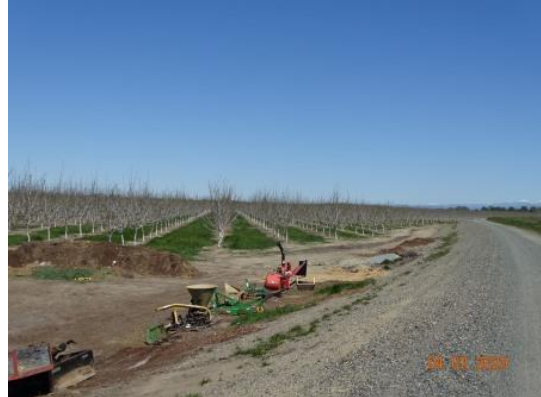
Photo 1 of 1 : SP\_2020\_LD0001G\_432\_11\_20200413\_00104.jpg

View of the materials and equipment along the landside toe. Spring 2020.

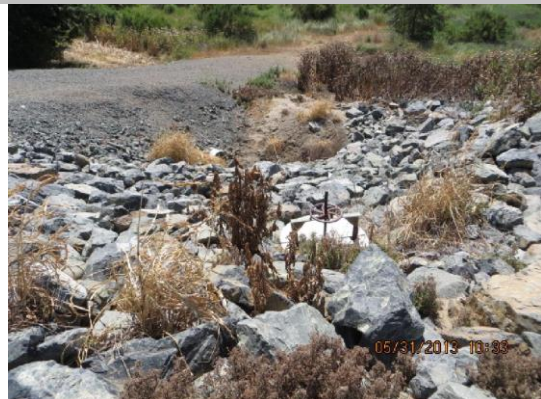
Photo 1 of 3 : UCIP\_SP\_2020\_14390\_23690.jpg

Slide gate in 36-inch CMP riser on WS slope.

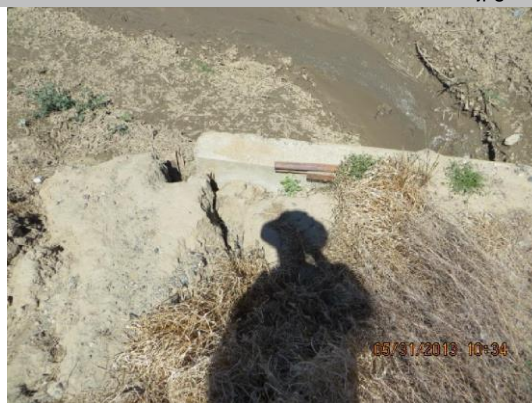
Photo 3 of 3 : UCIP\_SP\_2020\_14390\_23688.jpg

Erosion around headwall at LS toe.

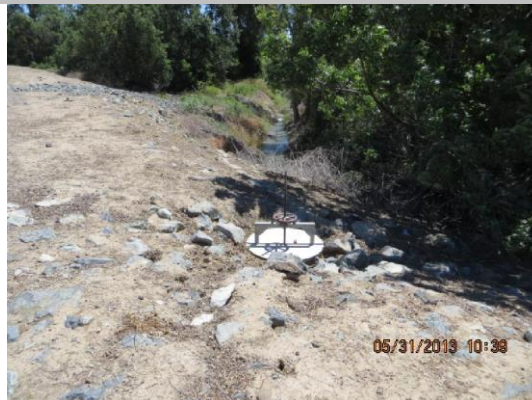
Photo 2 of 3 : UCIP\_SP\_2020\_14559\_23985.jpg

Slide gate in 36-inch CMP riser on WS slope.

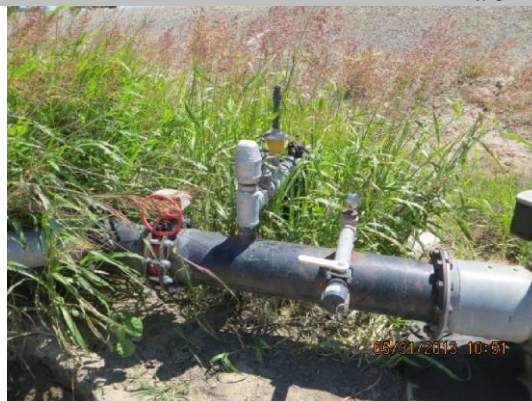
Photo 1 of 3 : UCIP\_SP\_2020\_16205\_27333.jpg

Pump with siphon breaker, vent and filter on LS toe.

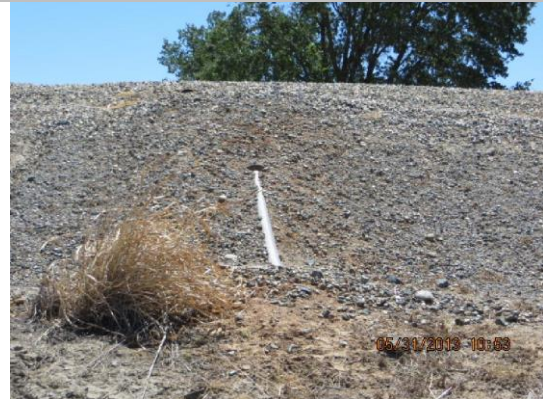
Photo 2 of 3 : UCIP\_SP\_2020\_16205\_27332.jpg

Pipe on LS slope.

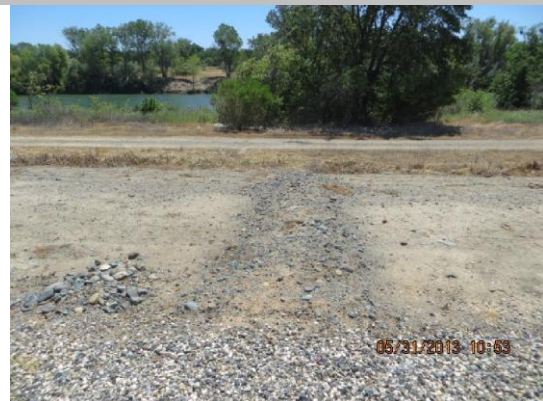
Photo 3 of 3 : UCIP\_SP\_2020\_16205\_27331.jpg

Cover over pipe on WS berm.

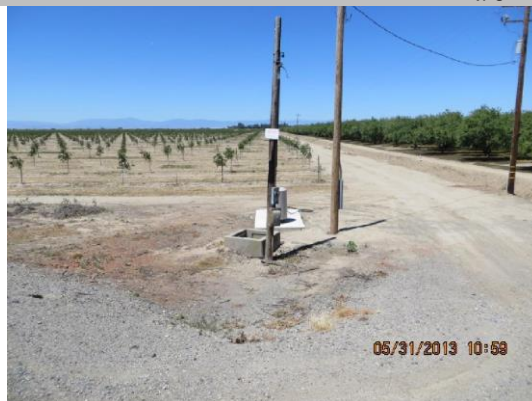
Photo 1 of 3 : UCIP\_SP\_2020\_14561\_23989.jpg

Concrete distribution box at LS toe.

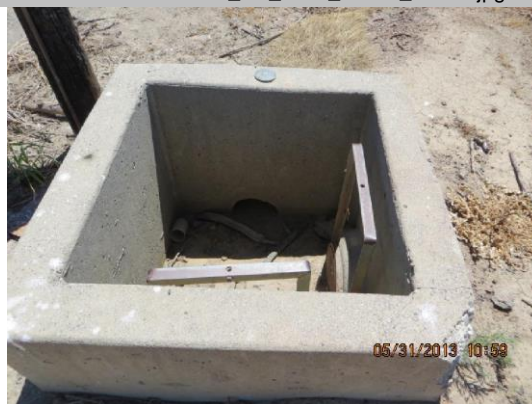
Photo 2 of 3 : UCIP\_SP\_2020\_14561\_23988.jpg

Concrete distribution box at LS toe with outlet from pipe through levee.

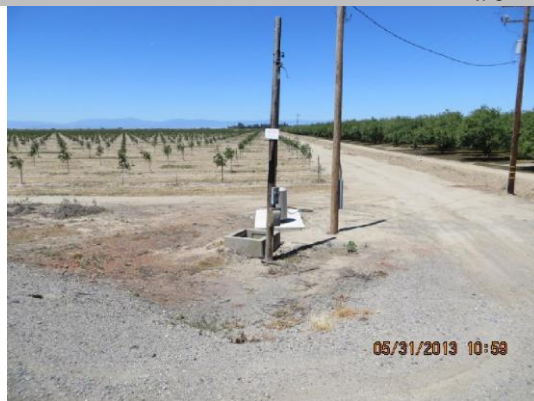
Photo 1 of 2 : UCIP\_SP\_2020\_14562\_23991.jpg

Source at JP next to concrete distribution box at LS toe.

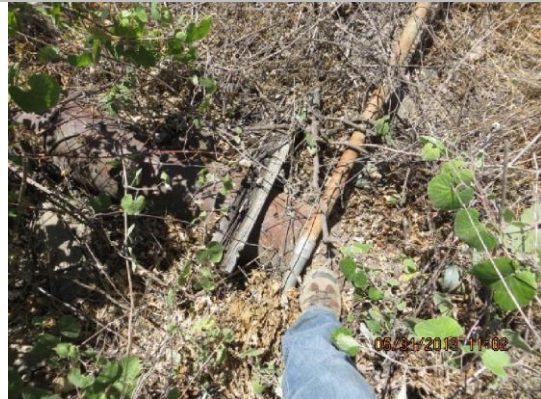
Photo 2 of 2 : UCIP\_SP\_2020\_14562\_23990.jpg

Pipe visible off WS toe.

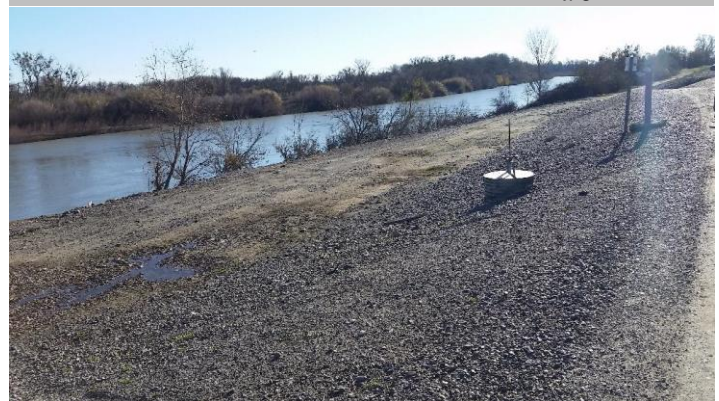
Photo 1 of 3 : UCIP\_SP\_2020\_53340\_76411.jpg

View of WS.

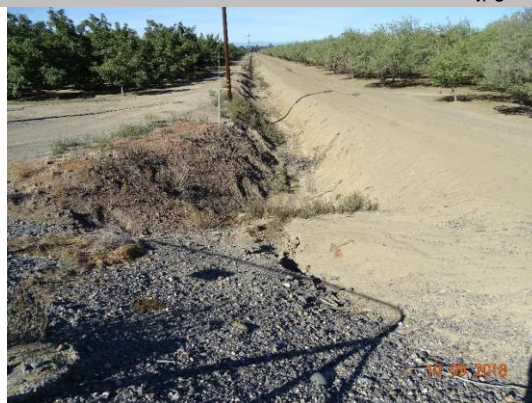
Photo 3 of 3 : UCIP\_SP\_2020\_53340\_78136.jpg

Drainage channel on LS.

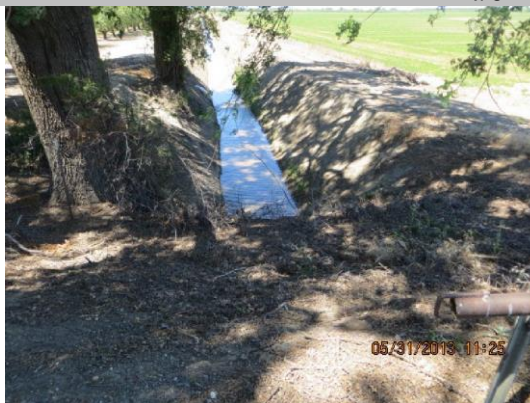
Photo 1 of 3 : UCIP\_SP\_2020\_14565\_24009.jpg

Drainage ditch on LS toe.

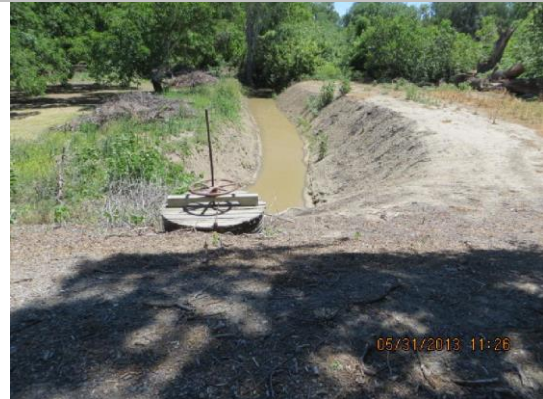
Photo 2 of 3 : UCIP\_SP\_2020\_14565\_24008.jpg

Slide gate in 60-inch CMP riser on WS slope.

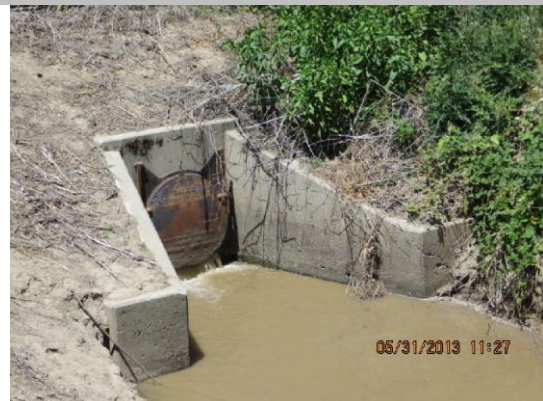
Photo 3 of 3 : UCIP\_SP\_2020\_14565\_24007.jpg

Flap gate and concrete headwall on WS toe.

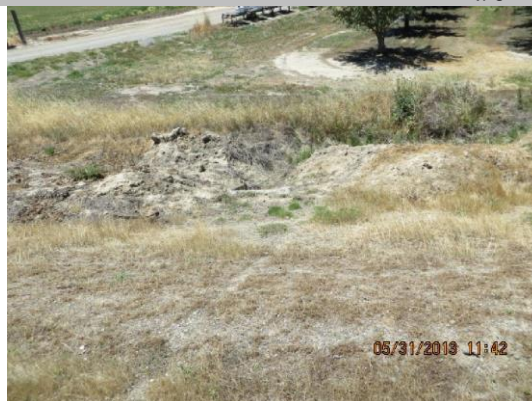
Photo 1 of 3 : UCIP\_SP\_2020\_14566\_24013.jpg

Concrete headwall on LS toe.

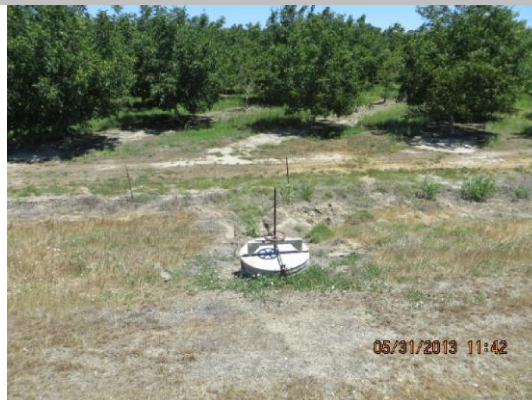
Photo 2 of 3 : UCIP\_SP\_2020\_14566\_24012.jpg

Slide gate in 36-inch CMP riser on WS slope.

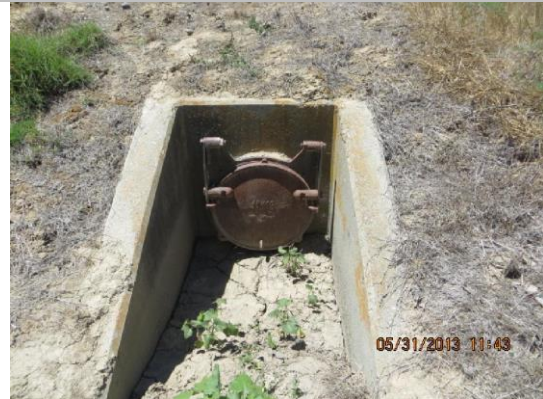
Photo 3 of 3 : UCIP\_SP\_2020\_14566\_24011.jpg

Concrete headwall and flapgate on WS toe

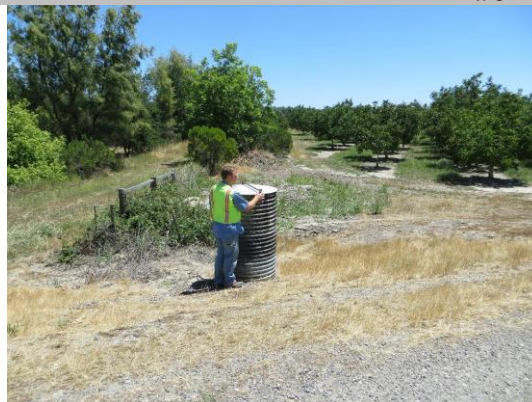
Photo 2 of 3 : UCIP\_SP\_2020\_14567\_24016.jpg

Slide gate in CMP riser on WS toe.

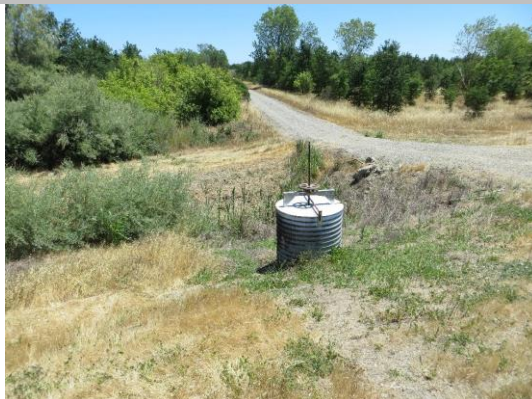
Photo 1 of 3 : UCIP\_SP\_2020\_14569\_24026.jpg

Slidegate in 36-inch CMP riser on WS slope.

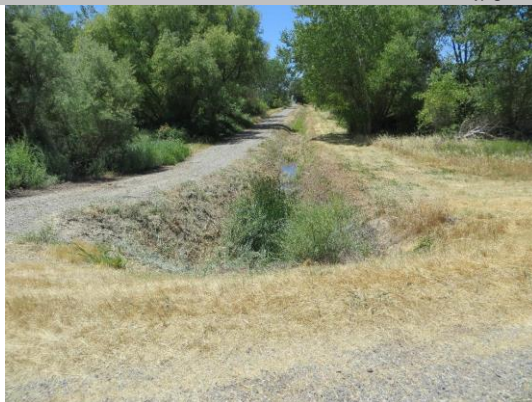
Photo 2 of 3 : UCIP\_SP\_2020\_14569\_24025.jpg

Drainage channel on LS toe.

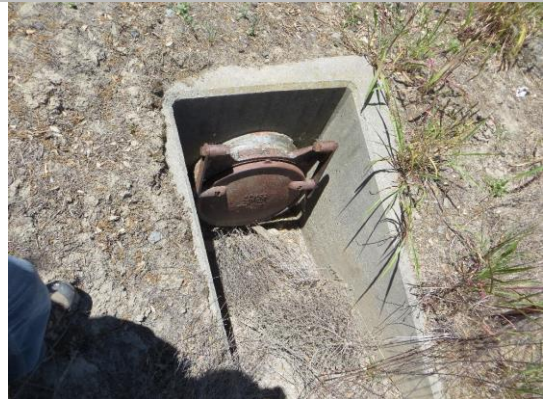
Photo 1 of 3 : UCIP\_SP\_2020\_14570\_24029.jpg

Flapgate and U-shaped concrete headwall on WS toe.

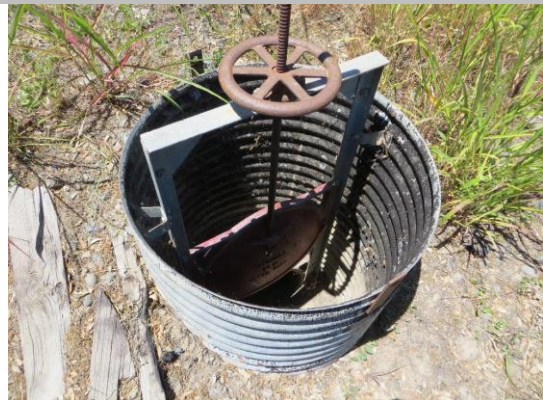
Photo 2 of 3 : UCIP\_SP\_2020\_14570\_24028.jpg

Slidegate in 36-inch CMP riser on WS slope.

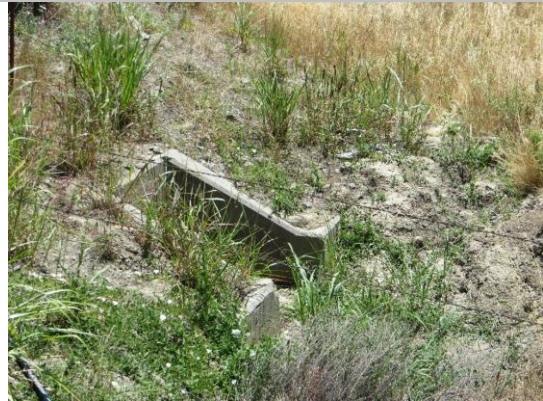
Photo 3 of 3 : UCIP\_SP\_2020\_14570\_24027.jpg

U-shaped concrete headwall on LS toe.
